**Kampung Mesilou landslide: The controlling factors****Ismail Abd Rahim, Lee Kiun You & Nabila Mohd Salleh***Natural Disasters Research Unit, Faculty of Science and Natural Resources, Universiti Malaysia Sabah, Jalan UMS, 88400 Kota Kinabalu, Sabah, Malaysia*

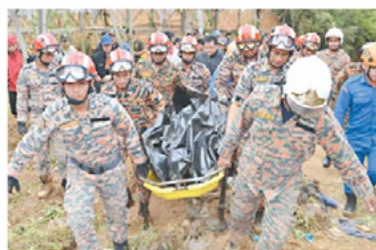
Engineering structures damages by landslide in Kundasang area has cost trillion of Ringgit Malaysia for reconstruction and repairs as well as loss of three (3) lives include an elderly woman behind a farm in Kampung Mesilou on 16 July 2013 (Photograph 1). Landslides in Kampung Mesilou are repeated and happened for fifth times i.e before 2008 (?), 2008, July 2013 and November 2013 as well as triggered by Kinabalu earthquake on June 2015 (Photograph 2 & Figure 1).

**Photograph 1** Victims of 16 July 2013 landslide (New Straits Times, 2013).

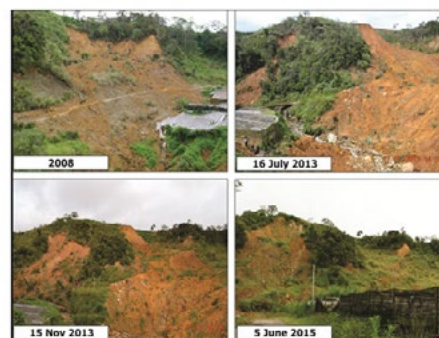
**Photograph 2** Landslides in 2008, 16 July 2013, 15 Nov 2013 and 5 June 2015.

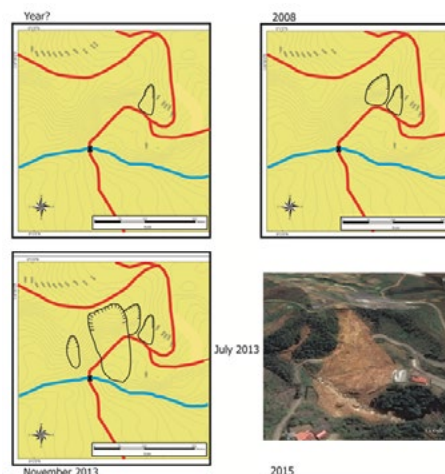
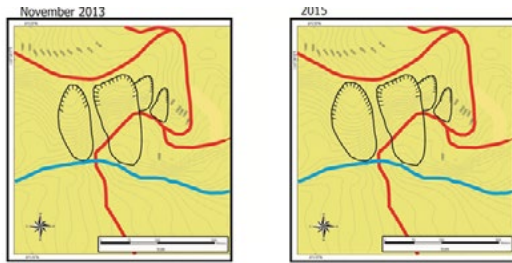
Figure 1 Events and satellite image on 20 July 2013 for Kampung Mesilou landslides.

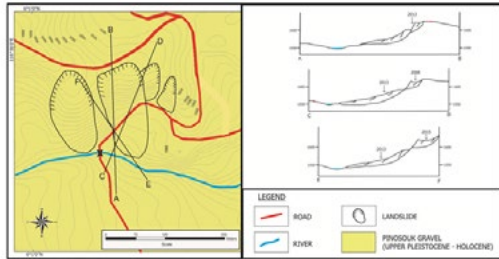
The Kampung Mesilou landslide is located at 6o00' 49"N and 116o36'5"E. This area is underlain by the poorly consolidated tilloid deposit that known as Pinosuk Gravel rock unit of Upper Pleistocene to Holocene in ages and consists of variety of gravel and sizes such as granodiorite, monzodiorite, adamellite, peridotite, slate, metasandstone (metaquartzite), sandstone and shale in argillaceous groundmass (Figure 2 and Photograph 3). Maximum thickness of this rock unit is 150 meter (Hutchison, 2005).

Figure 2 Geological map and Kampung Mesilou landslide zones.

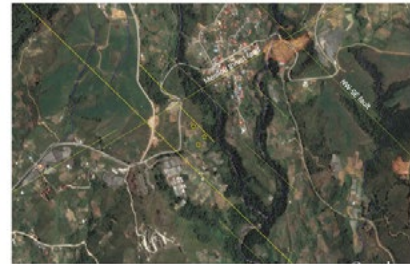
Figure 3 Mesilou and northwest-southeast fault lines.

Aerial photograph, satellite images and field studies are also found that the kg Mesilou landslide is located in intersection of active thrust Mesilou fault zone of Tongkul and Shariff (2009) (Figure 3). Fault zone is a crush and very weak zone. Material that crossed this zone will be move easily especially in hilly or sloping areas.

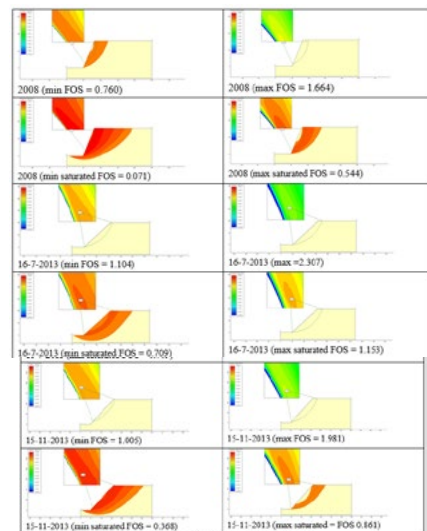
Slope stability analysis has been conducted for the slopes with their geometries as shown in Table 2. The results are shown in Table 2 and Figure 4. Landslide in 2008, July 2013 and Nov 2013 show that all of the slopes is stable for normal condition but during the rainy session or saturated condition, all the slopes are unstable with FOS < 1

Year	H (meter)	W (meter)	β (degree)	Min FOS	max FOS	Min Saturated FOS	Max Saturated FOS
2008	80	70	68	0.76	1.664	0.071	0.544
16-7-2013	100	120	43	1.104	2.307	0.709	1.153
15-11-2013	120	80	48	1.005	1.981	0.368	0.861

Figure 4 Slope stability model and FOS.
