Geological Behavior (GBR)

ENGINEERING GEOLOGICAL STUDY ON THE SLOPE FAILURE ALONG THE KIMANIS TO KENINGAU HIGHWAY, SABAH, MALAYSIA

Rodeano Roslee^{1,2*}, Felix Tongkul^{1,2}

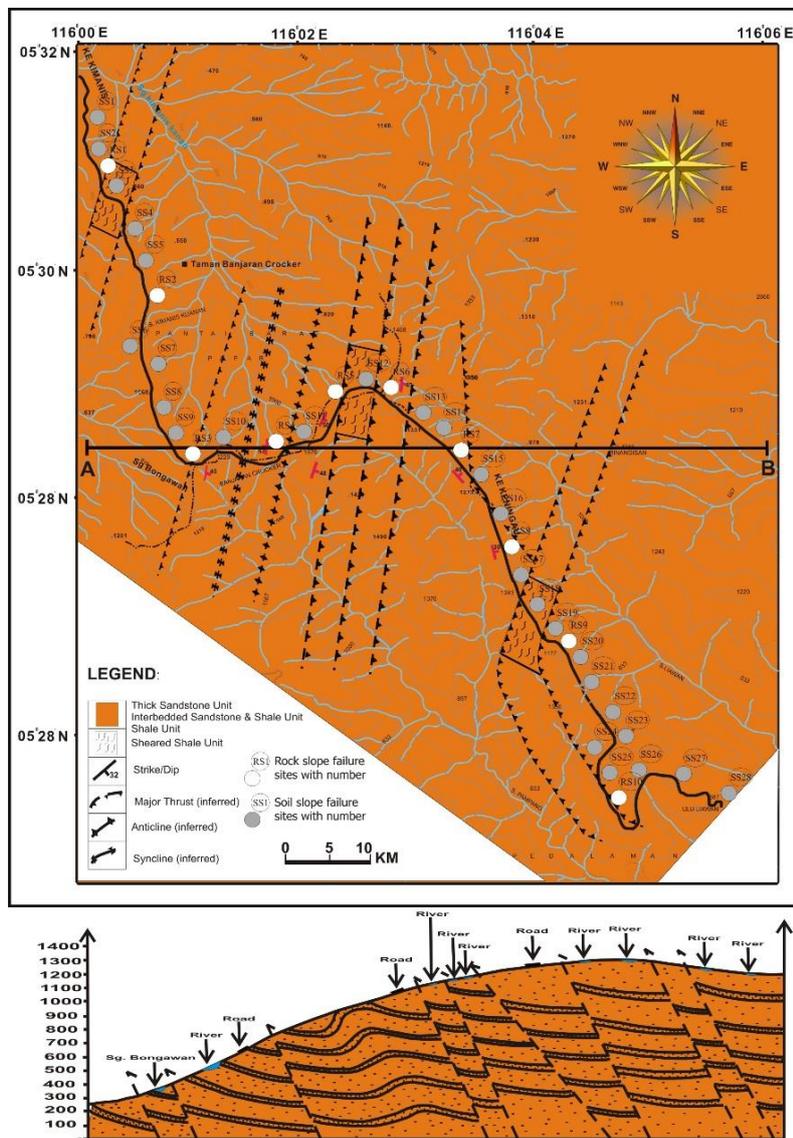
Figure 2: Geological map with their location of slope failures [24]

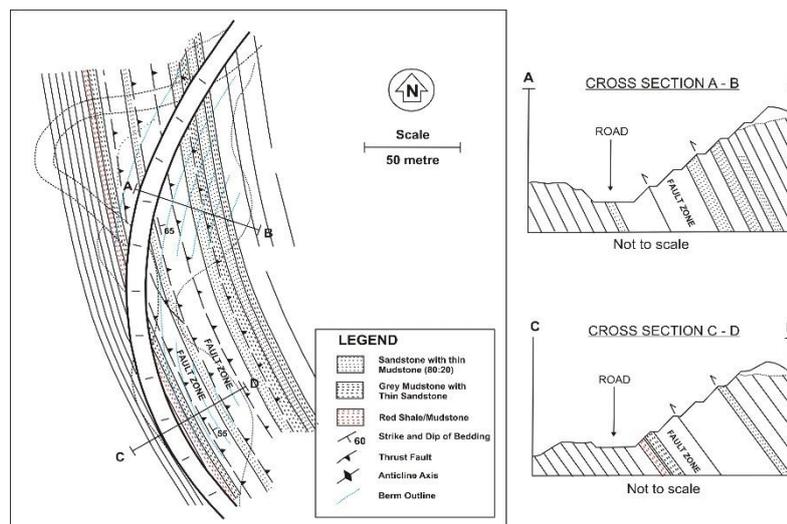
In this study, a total of 28 selected critical slope failures were studied and classified into two main groups: rock slope and soil slope (Figure 2). Failures in soil slopes (including embankments) are 18 (64 %) (Figure 3) whereas 10 of all failures (36 %) of rock slope (Figure 4). Soil slope failures normally involved large volumes of failed material as compared much rock slopes, where the failures are mostly small. Of the 18 failures in soil slopes, 6 (33 %) are embankment failures making them 21 % of all types of failure.

Figure 3: Sketch of slope failure showing the failure movement are starting from the hill side to the road and/or village sides through the development of water runoff (Location: KM 134 (S8)) [24]

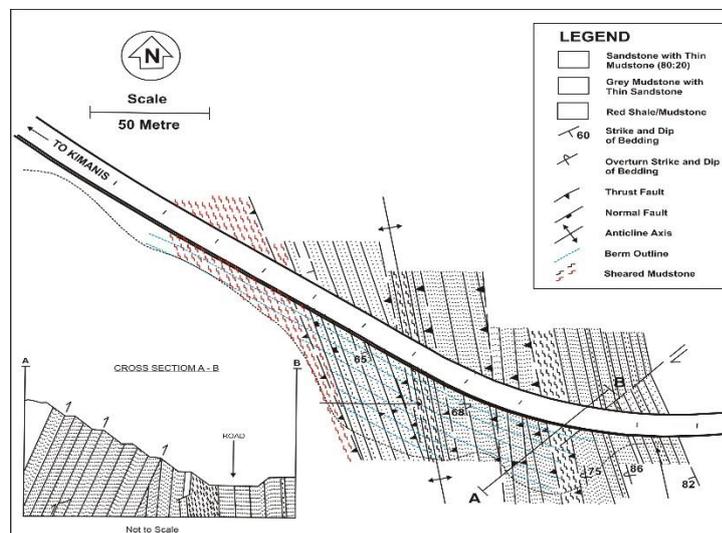
Figure 4: Sketch of slope failure showing the movement pattern is to collapse at the head, fall rapidly within narrow tracks, finally dispersing across the accumulation talus deposits (Location: KM 156 (R8)) [24]
