4. SLOPE STABILITY ASSESSMENT

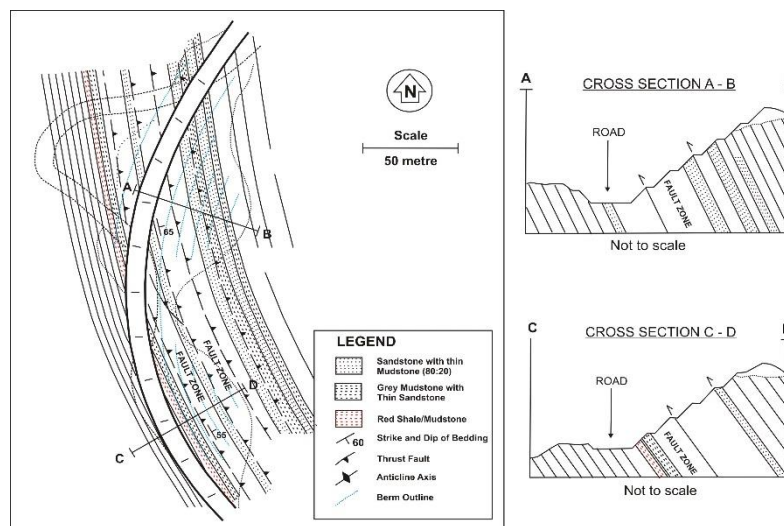
In this study, a total of 28 selected critical slope failures were studied and classified into two main groups: rock slope and soil slope (Figure 2). Failures in soil slopes (including embankments) are 18 (64 %) (Figure 3) whereas 10 of all failures (36 %) of rock slope (Figure 4). Soil slope failures normally involved large volumes of failed material as compared much rock slopes, where the failures are mostly small. Of the 18 failures in soil slopes, 6 (33 %) are embankment failures making them 21 % of all types of failure.

Figure 3: Sketch of slope failure showing the failure movement are starting from the hill side to the road and/or village sides through the development of water runoff (Location: KM 134 (S8)) [24]

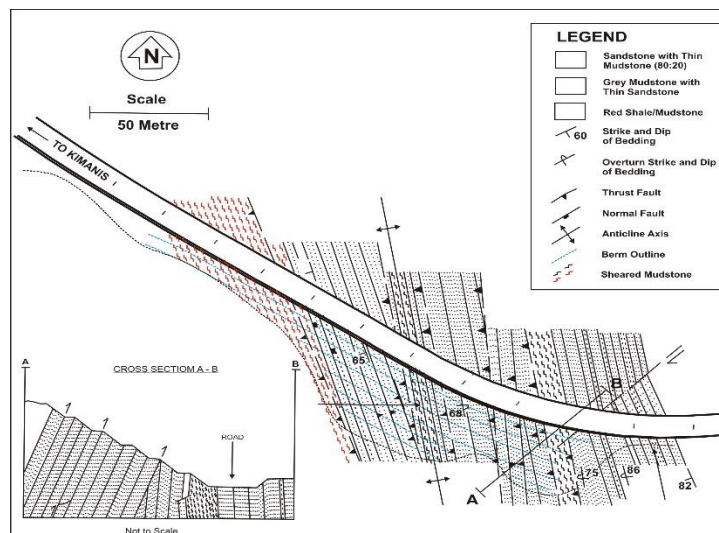
Figure 4: Sketch of slope failure showing the movement pattern is to collapse at the head, fall rapidly within narrow tracks, finally dispersing across the accumulation talus deposits (Location: KM 156 (R8)) [24]
