GEOMETRIC AND SPATIAL ASSESSMENT OF URBAN ROAD POTHOLES IN YENAGOA, BAYELSA STATE, NIGERIA

Hart, Lawrence, Pepple, Godwill T, Oriango, Numoyu

Department of Surveying and Geomatics, Rivers State University, Port Harcourt, Nigeria

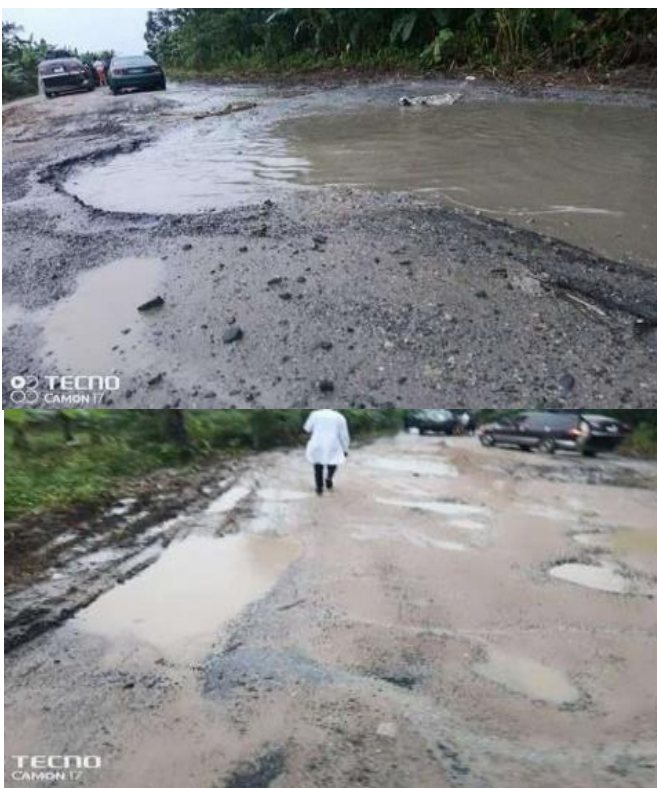
Plate 1: Specimen of a typical pothole on some of the Roads within the Study Area

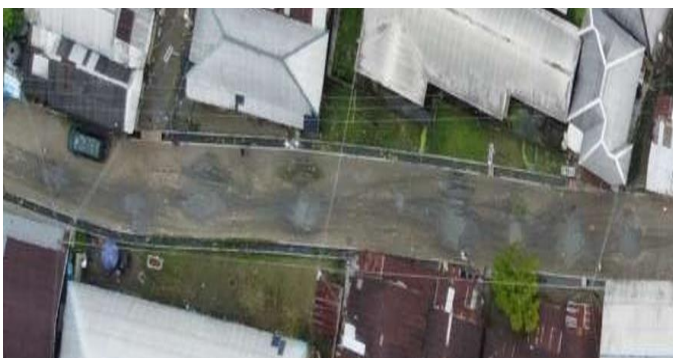
Figure 5: Orthophoto Map of the Section of Ebi's Mechanic Road in Yenagoa City

The Ebi-Mechanic Road, Amarata, recorded the highest pothole density, with 51 potholes covering approximately 21.09% of the road surface (11,958.90 m²). The significantly larger surface area and volume of potholes along this corridor indicate advanced material degradation, likely associated with persistent water infiltration, poor subgrade compaction, and repeated mechanical loading. From a geological perspective, such conditions promote the loss of fine-grained sub-base materials through erosion and pumping, accelerating surface collapse. In contrast, Goodnews Road exhibits a relatively low pothole coverage (5.04%) despite observable surface defects. This suggests comparatively improved subsurface stability or reduced exposure to moisture ingress. Saptex Road, with 39 potholes affecting 11.79% of its surface area, represents an intermediate condition, where localized failure zones dominate over systemic structural breakdown. These spatial variations underscore the influence of heterogeneous subsurface conditions and differential stress distribution across the road network. Azikoro Road, despite being the longest and widest road, does not exhibit the highest pothole density, indicating that geometric road dimensions alone do not govern pothole formation.
