## Rock Slope Stability Assessment of Limestone Hills in Northern Kinta Valley, Ipoh, Perak, Malaysia

Limestone, failure modes, rock slope stability assessment

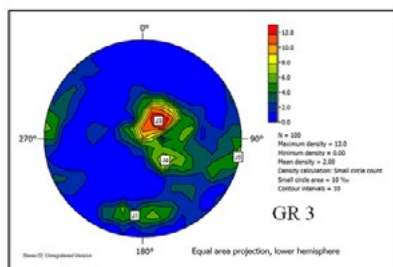
Figure 17: Stereograph for slope GR3, Gunung Rapat, Ipoh, Perak, Malaysia.

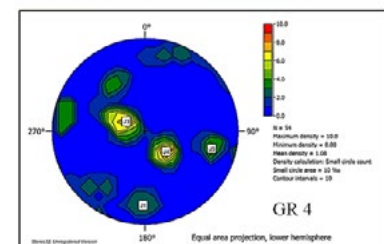
Figure 18: Stereograph for slope GR4, Gunung Rapat, Ipoh, Perak, Malaysia.

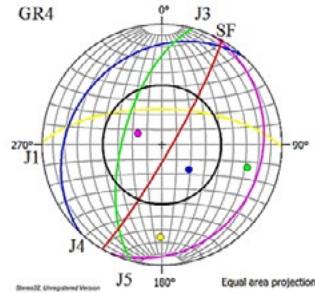
Figure 27: Kinematic analysis for slope GR4, Gunung Rapat using friction angle of 49°. No mode of failure on this slope.

| Slope | Friction angle $\phi$ | Joint Roughness Coefficient (JRC) | Failure Mode |
|---|---|---|---|
| GR4 | 49 | 7 | No failure |

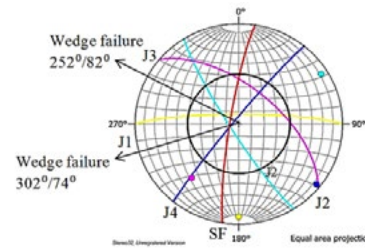
Figure 28: Kinematic analysis for slope QXL1, Qing Xing Ling using friction angle of 49°. From the kinematic analysis, two wedge failures were identified. The dip direction/dip angle for the respective wedge failures were 252°/82° and 302°/74°.

| Slope | Friction angle $\phi$ | Joint Roughness Coefficient (JRC) | Failure Mode |
|---|---|---|---|
| QXL1 | 49 | 7 | Wedge failure: 252°/82°<br>Wedge failure: 302°/74° |
