ROCK SLOPES KINEMATIC ANALYSIS ALONG THE BUNDU TUHAN TO KUNDASANG HIGHWAY, SABAH, MALAYSIA

This study focused on the discontinuity survey and mode of rock slope failure along the Bundu Tuhan to Kundasang road, approximately 84th km to 96th km from Kota Kinabalu city, Sabah. The area is underlain by the Trusmadi Formation (Palaeocene to Eocene age), the Crocker Formation (Late Eocene to Early Miocene age) and the Pinousuk Gravels (Upper Pleistocene to Holocene age). These rock units show numerous lineaments with complex structural styles developed during several regional Tertiary tectonic activities. The tectonic complexities reduced the physical and engineering properties of the rock masses and produced intensive displacements and discontinuities among the strata, resulting in high degree of weathering process and instability. The weathered materials are unstable and may cause sliding and falling induced by high pore pressure subjected by both shallow and deep hydrodynamic processes. In this study, a total of ten (10) selected critical rock slopes failure was studied. Kinematics slope stability analyses indicates that the variable potential of circular, planar, wedge and toppling

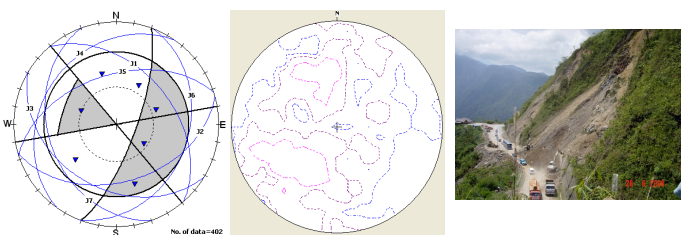
Figure 2: Streoplots and view of rock slope failure for the location of East KM 82.00

There are seven (7) sets of joints (J1-J7) (Figure 2) which intersecting randomly in all direction and intersection point fall outside from the critical zone or plunge of the intersect planes less then 30o (friction angle), then formation of wedge failure on this slope is not possible. Joints J4 and J6 is the most critical plane in this location because their orientation almost parallel to the slope face and their dip vector and pole point falls into the critical zone which creating the circular failure, planar failure or toppling failure, respectively.

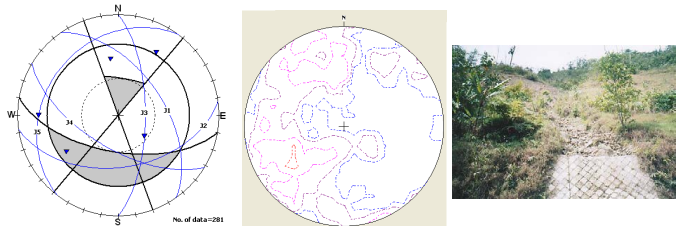
Figure 3: Streoplots and view of rock slope failure for the location of East KM 84.00

This location has five (5) major sets of joints (Figure 3). Three intersection points (J3 X J4, J2 X J3 and J2 X J4) of the joints has been recognized and falls in critical zone to create three potential wedge failures. Joints J2 and J3 are become critical planes while other joints (J1, J4 and J5) as release planes of wedge failure in this location.

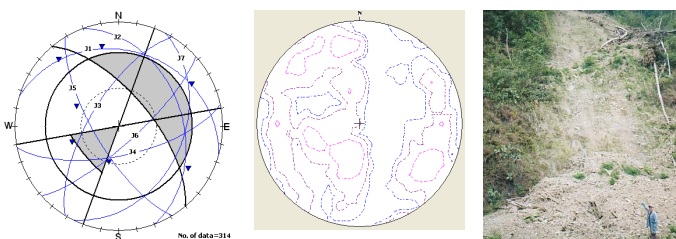
Figure 4: Streoplots and view of rock slope failure for the location of East KM 84.40

Seven (7) sets of joints have been identified in this location (Figure 4). One potential circular failure and two potential wedge failures can be created by intersections point of joint J2 X J6 and J2 X J4 X J7 which fall within critical zone with joint J4 and J6 become critical planes. Parallel orientation but opposite dip direction of joint J5 and slope face has been interpreted for possibility occurrence of toppling failure in this location because pole point of joint J5 is falls just behind the critical zone.

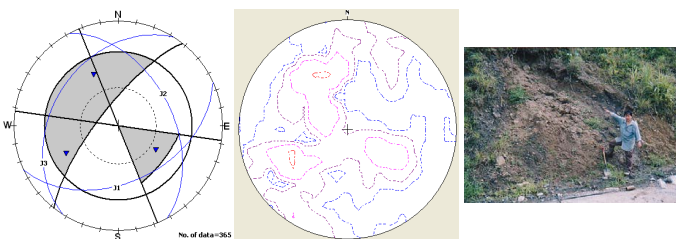
Figure 5: Streoplots and view of rock slope failure for the location of South KM 87.45

Kinematics analysis in this location has been produced three (3) joints sets (Figure 5). The potential failure is planar failure according to fallen dip vector of J3 inside the critical zone. Joint J3 is also identified as critical plane as well as release plane of joints J1 and J2.

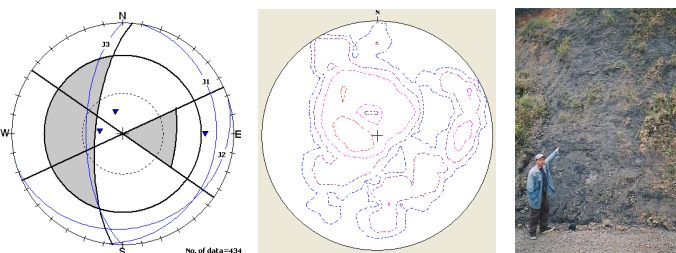
Figure 6: Streoplots and view of rock slope failure for the location of South KM 87.90

Nearly parallel orientation of joint J3 and slope face has been creating a planar failure in this location (Figure 6). This planar failure is also generated by the occurrences of release planes (joints J1 and J3) and critical plane of joint J3.

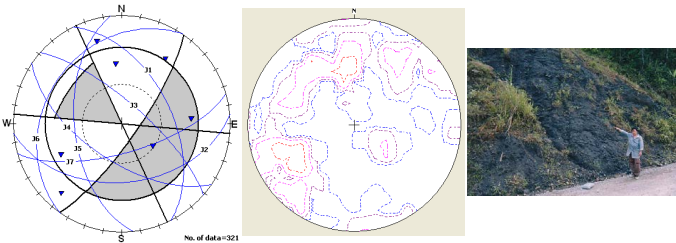
Figure 7: Streoplots and view of rock slope failure for the location of East KM 84.90

Seven (7) joints set have been recognized in this location (Figure 7). One circular and four wedge failures are also identified to be potential due to four joint intersection points (J3 X J7, J1X J3, J1 X J2 and J2 X J3) fall in critical zone. Joints J1, J2 and J3 become a critical planes and joints J1, J3, J4 and J5 contributed as release planes. Possible toppling failure has been identified by the occurrences of pole point and dip vector of joint J6 inside and outside the critical zone, respectively. The joint J6 is also a critical plane for possibly toppling failure in this slope.

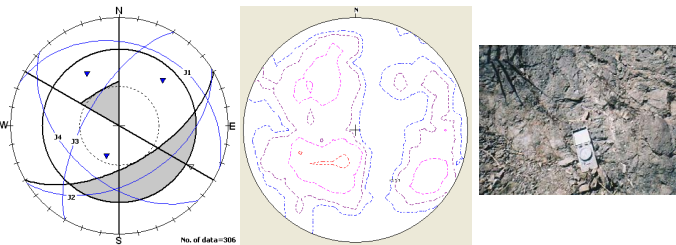
Figure 8: Streoplots and view of rock slope failure for the location of East KM 85.50

Stereonet analysis in this location indicates four (4) sets of joints and only a point of intersection falls in the critical zone (Figure 8). This means a wedge failure has been a potential wedge failure resulted from intersection of joint sets J2 X J4 which enhance by released planes of joint J1, J2 and J3 as well as critical plane of J4. Parallel orientation of slope face with joint J2 and the dip vector of joint J2 falling inside critical zone contributing to the formation of planar failure in this location. Opposite dip directions of slope face and joint J3 with nearly same direction on their orientation are also contributing to the possibility of toppling failure occurrence.

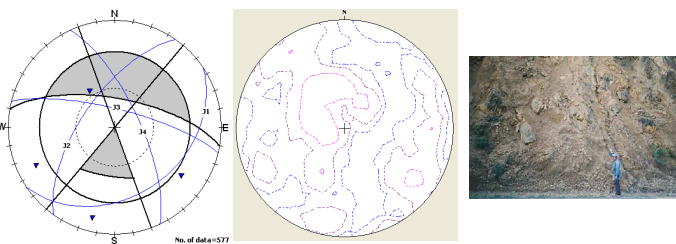
Figure 9: Streoplots and view of rock slope failure for the location of East KM 86.80

Potential wedge failure and possible planar failure has been identified in this location (Figure 9), respectively. Intersection point of joint J2 X J4 in critical zone creating a sliding plane of wedge failure and nearly parallel orientation of joint J3 with the slope face for planar failure. Joints of J2 plane and J3 have become critical planes in this location.

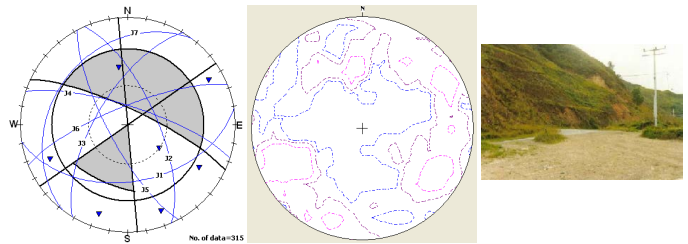
Figure 10: Streoplots and view of rock slope failure for the location of East KM 92.50

One potential circular failure with two potential wedge failures and a planar failure have been recognized in this location (Figure 10). Falling of joint intersection point (J2 X J3 and J2 X J6) and dip vector of joint J4 in the

critical zone has resulted in wedge failure and planar failure. Joint J3, J2 and J4 have become the critical planes these circular, wedge or planar failures.

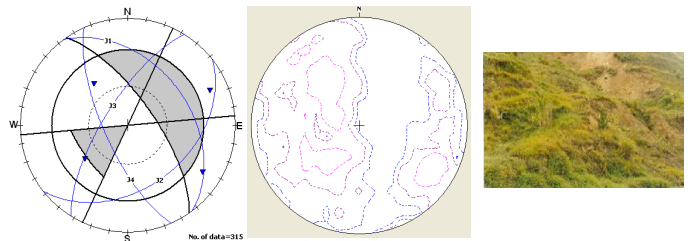
Figure 11: Streoplots and view of rock slope failure for the location of East KM 95.70

Two intersection point and a dip vector have been identified fall within critical zone in this station which can be interpreted as two potential a wedge failure and a planar failure, respectively. The wedge failure will be generated by intersection of joint J1 X J3 and J1 X J2 as well as contribution of critical planes of joints J2 and J3 for this failure. Joint J1 is also a critical plane for the formation of planar failure which created by parallel orientation with the slope face.
