ROCK SLOPE STABILITY ASSESSMENT OF LIMESTONE HILLS, SOUTHERN KINTA VALLEY, IPOH, PERAK, MALAYSIA

ABSTRACT

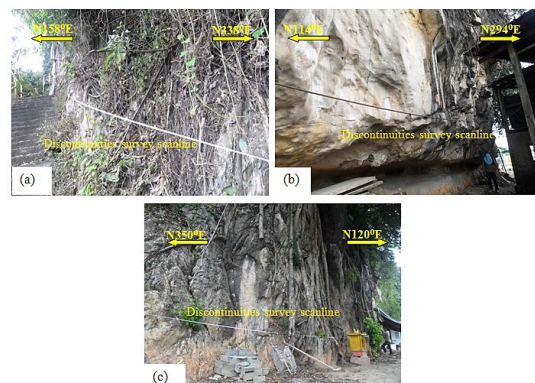
Three slopes were investigated at Gua Naga Mas which were labelled as GNM1, GNM2 and GNM3. The outcrops of the slopes are shown in Figure 3. The stereographs of respective slopes are shown in Figure 4. The peak friction angle for GNM1 was 55° . The peak friction angle for both GNM2 and GNM3 was 49° . Figure 5 shows the results of kinematic analysis for respective slopes. Based on the kinematic analysis, four wedge failures and a planar failure were identified at slope GNM1 and the dip directions/dip angles for respective wedge and planar failures were $005^\circ/54^\circ$, $354^\circ/59^\circ$, $124^\circ/52^\circ$, $360^\circ/50^\circ$ and $063^\circ/70^\circ$, respectively. The mode of failure identified at slope GNM2 was wedge failure with the dip direction/dip angle of $021^\circ/64^\circ$ whereas two wedge failures and a planar failure were identified at slope GNM3. The dip directions/dip angles for respective wedge and planar failures at slope GNM3 were $336^\circ/49^\circ$, $301^\circ/68^\circ$ and $270^\circ/71^\circ$, respectively. Table 3 shows the summary of rock slope assessment at Gua Naga Mas according to failure mode, failure direction, peak friction angle and joint roughness coefficient.

Figure 3: Discontinuity survey scanlines at the outcrop of (a) slope GNM1, (b) GNM2 and (c) GNM3 for Gua Naga Mas, Simpang Pulai, Perak.

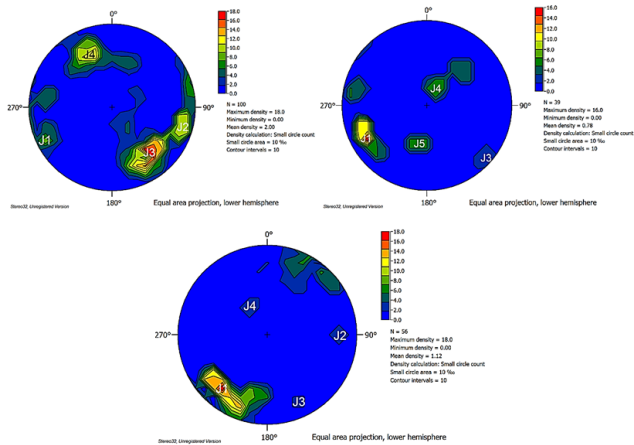
Figure 4: Stereographs for slopes of (a) GNM1, (b) GNM2 and (c) GNM3 for Gua Naga Mas, Simpang Pulai, Perak.

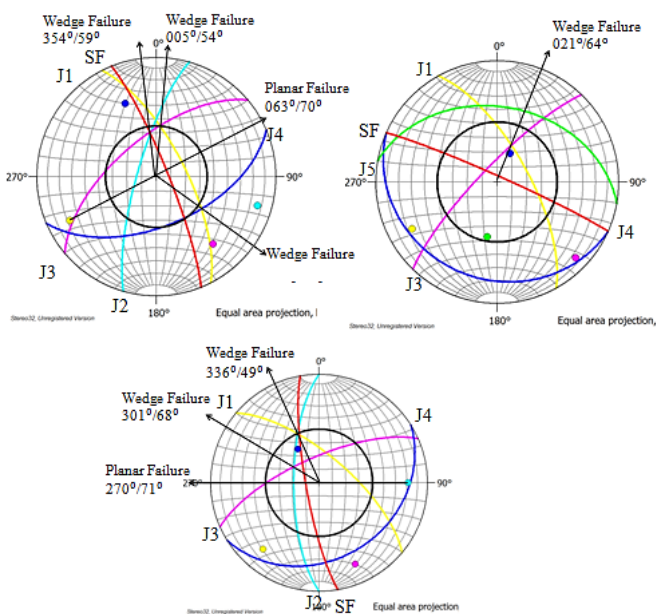
Figure 5: Kinematic analysis of (a) slope GNM1, (b) GNM2 and (c) GNM3 for Gua Naga Mas, Simpang Pulai, Perak.

Slopes	Failure mode	Failure direction	Peak friction angle	Joint roughness coefficient
GNM1	Wedge failure	005°/54°	55	9
	Planar failure	063°/70°		
GNM2	Wedge failure	021°/64°	49	7
GNM3	Wedge failure	336°/49°	49	7
	Planar failure	270°/71°

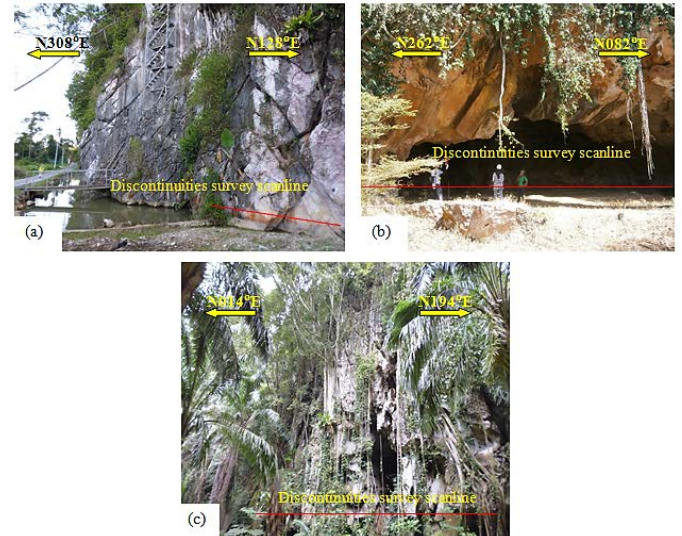
Three slopes were investigated at Gua Kandu and were labelled as GK1, GK2 and GK3. The locations of the respective slopes are shown in Figure 6. The stereographs of the respective slopes where are shown in Figure 7. The peak friction angle for slope GK1, GK2 and GK3 were 49°, 36° and 55° respectively. Figure 8 shows the results of kinematic analysis for the respective slopes. The mode of failure for slope GK1 were wedge and planar failures with the dip directions/dip angles for wedge and planar failures as 231°/49° and 217°/49°, respectively. The mode of failure at slope GNM2 was wedge failure with the dip direction/dip angle of 154°/

Figure 6: Discontinuity survey scanlines at the outcrop of (a) slope GK1, (b) GK2 and (c) GK3 for Gua Kandu, Gopeng, Perak

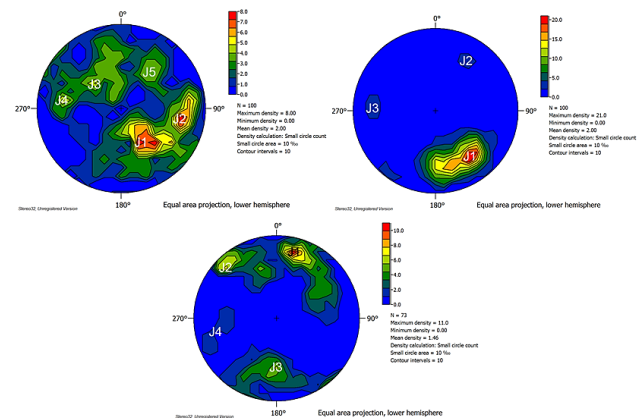
Figure 7: Stereograph of (a) slope GK1, (b) GK2 and (c) GK3 for Gua Kandu, Gopeng, Perak

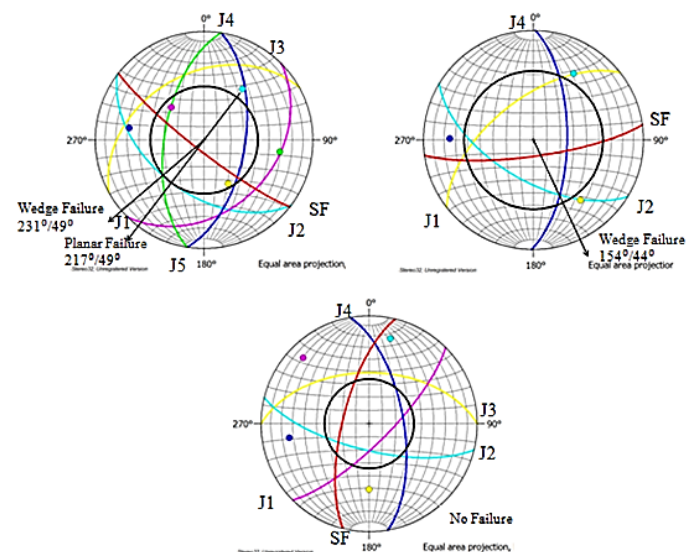
44°. No mode of failure was identified at slope GK3. Table 4 shows the summary of rock slope stability assessment at Gua Kandu according to failure mode, failure direction, peak friction angle and joint roughness coefficient.

Figure 8: Kinematic analysis of (a) slope GK1, (b) GK2 and (c) GK3 for Gua Kandu, Simpang Pulai, Perak

Slopes-	Failure mode	Failure direction	Peak friction angle	Joint roughness coefficient
GK1	Wedge failure	231°/49°	49	7
	Planar failure	217°/49°		
GK2	Wedge failure	154°/44°	49	3
GK3	No failure		55	5

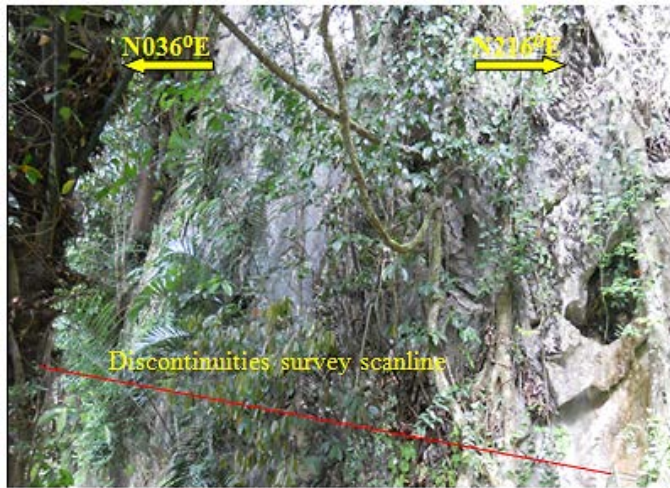
The slope investigated at Gua Tempurung was labelled as GT. The location of the slope is shown in Figure 9. The stereograph of the slope is shown in Figure 10. The peak friction angle for GT was 49°. Figure 11 shows the results of kinematic analysis for slope GT. Two wedge failures were identified on slope GT with dip directions/dip angles of 011°/49° and 321°/48°. Table 5 shows the summary of rock assessment at Gua Tempurung according to failure mode, failure direction, peak friction angle and joint roughness coefficient.

Figure 9: Discontinuity survey scanlines at the outcrop of slope GT for Gua Tempurung, Gopeng, Perak

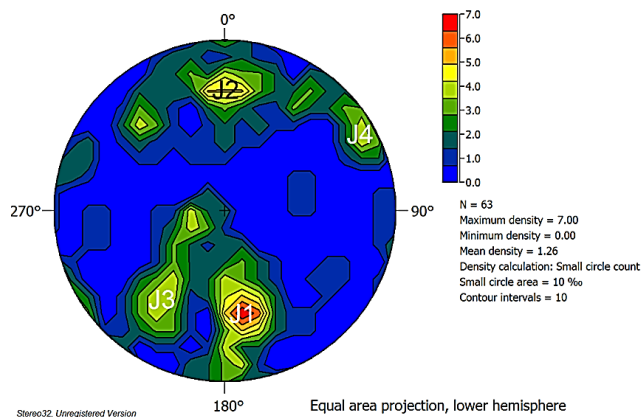
Figure 10: Stereograph of slope GT for Gua Tempurung, Gopeng, Perak

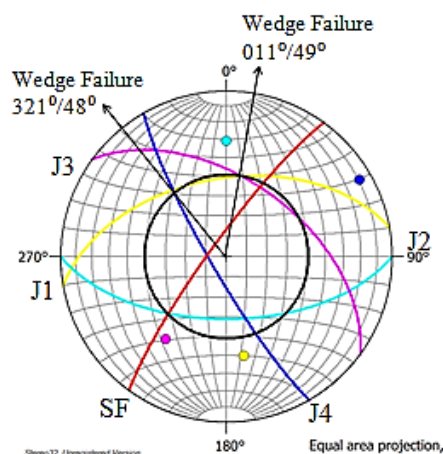
Figure 11: Kinematic analysis of slope GT for Gua Tempurung, Gopeng, Perak

Slope	Failure mode	Failure direction	Peak friction angle	Joint roughness coefficient
GT	Wedge failure	011°/49° 321°/48°	49	7
