# Geological Behavior (GBR)

## URBANIZATION VS. ENVIRONMENTAL QUALITY: SOME OBSERVATION IN TELIPOK, SABAH, MALAYSIA

Ismail Abd Rahim<sup>1,2</sup>, Sanudin Tahir<sup>1,2</sup>, Baba Musta<sup>1,2</sup>, Rodeano Roslee<sup>1,2</sup>

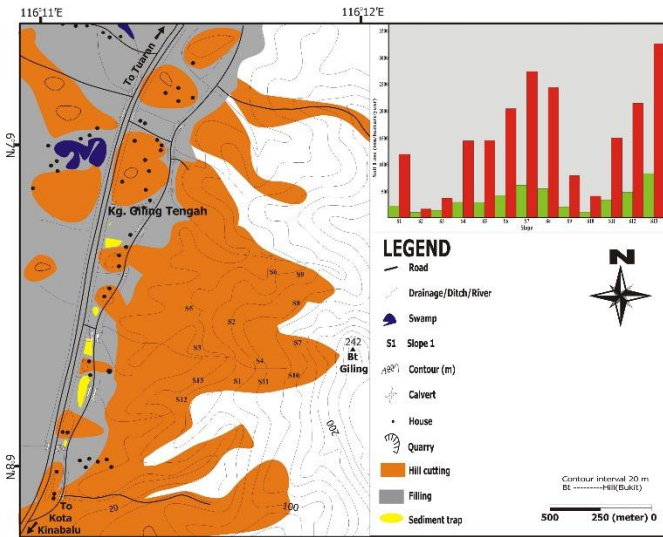
USLE has been used in this study because soil erosion caused by disturbance of physical terrain and slope stability to estimate the erosion in two difference situation i.e fresh and weathered rock. The north eastern part of the study area has been selected for this estimation due to slope and cutting activities in this area (Figure 4)

Result of this soil loss estimation in the study area are shown in Table 2 and shows that the rate of soil loss is high and critical i.e. 379.33 tan/hectare/year (K=0.2) and 1517.32 tan/hectare/year (K=0.05) which above the limit of Department of Agriculture (Table 3) [22].

**Figure 4:** Map of the cutting and filling area, slope location, new 'natural sediment trap' and histogram of the soil loss estimation.

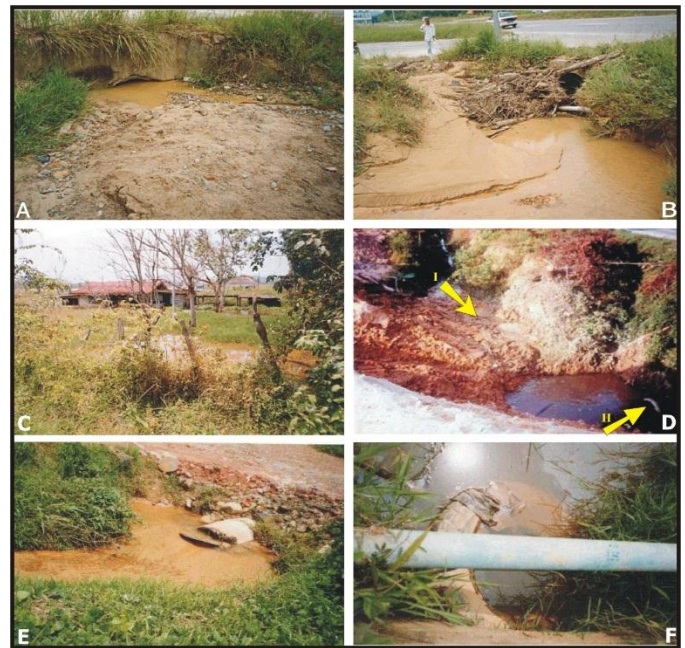
**Figure 5:** Factor causing environmental problem in the study area. A. Clog along the drain. Small and shallow ditch and siltation in the upper part of the culvert. B. Small culvert and partition of debris. C. Demolish house in the swampy area and grass field in the new natural sediment trap originated from paddy field. D. Congestion at the channel flow. The '90° corner' drainage channel (arrow I flowing to north and arrow II to the west) and small culvert (arrow II). E. Improper monitoring and maintenance of drainage channel to the solid waste and wild grass. F. Lack of enforcement of the environmental regulation (partition of debris and siltation).

Sediment accumulation and rising in surface level has been observed in '90° corner' drainage channel, front of culvert and the new 'natural sediment trap' reducing the drainage channel and culvert load capacity (Figure 5A and 5B) and submerging settlement house (Figure 5C), respectively.

Construction of a small and shallow drainage (ditch) channel with 1 m depth from road's surface decreases the channel capacity (Figure 5B) and may caused immediate changes in vertical pattern of channel bed level. This in turn has change the paddy field and flood plain in the middle of the study area to become a new natural sediment trap and swampy area (Figure 5C). Smaller culvert is also contributing to increase in the siltation and lost of the smoothness of the drainage flow (Figure 5A, 5B, 5D & 5E).

Attitude of the surrounding public community also contribute to flash flood problem in the study area. Solid waste management of industrial, residential and settlement area is not handled in proper way but left, dump, assemble and thrown into drainage channel (Figure 5E & 5F).

Any urbanization activities which potentially modified drainage system and flow must be supported by a completed EIA report. The existing regulation must be implemented and enforced to monitor and maintain drainage channel from the debris (Figure 5B), solid waste (Figure 5E & 5F), wild grasses (Figure 5F) and siltation in the upper part and outlet part of culvert (Figure 5A & 5B).

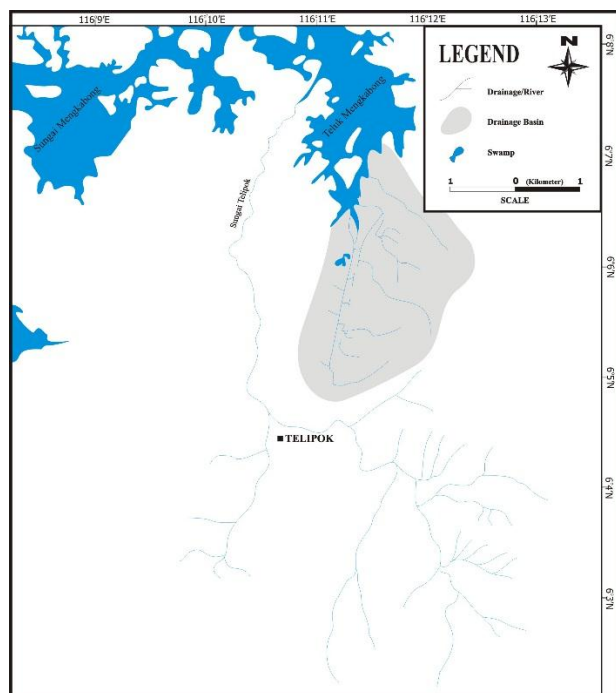
Nevertheless, sediment transport in the study area has been blocked or trapped in certain point due to the changes in natural drainage system or basin. The drainage pattern were reconstructed into 'L corner' or '90° corner' (Figure 2 & 5D), the drainage basin become 'shoes-shape' (Figure 6) and the new 'natural sediment trap' has produced (Figure 4 & 5C). The bottom of the drainage channel is also not at the same level or sloping into the sea (Teluk Mengkabong) smoothly.

Figure 6: The 'shoes-shape' drainage basin

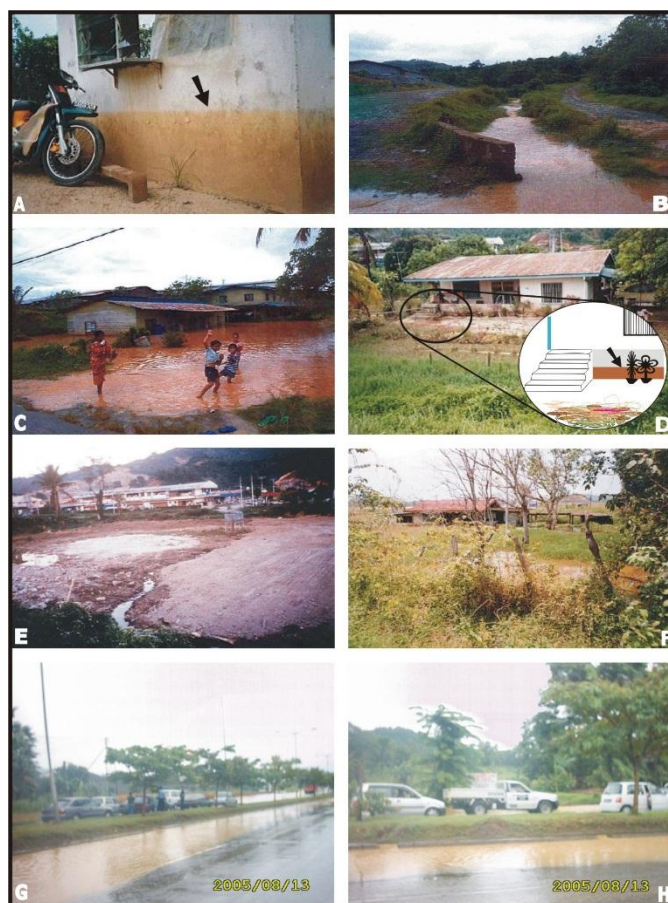
The major effects of flash flood in the study area are submergence of the flood plain area. This led to traffic congestion at Tuaran road and Jalan Lama Tuaran, as well as submerging some settlement houses (Figure 7C) and to create unique phenomena i.e. 'stair without pole' (Figure 7D) and neglected houses (Figure 7C, 7D, 7E and 7F).

Figure 7: Flash flood in the study area. A. Trace of water level (arrow) or flash flood in Ho Wah Genting Coach's guard post at km 26 of Tuaran road. B. Raising of drainage water level during a single heavy rainstorm event on May 1995 (source from Wailey, Dept. of Irrigation and Drainage, Tuaran). C. The flash flood on May 1995. Original condition of 'stair without pole' house, view to the south eastern (Source from Wailey, Dept. of Irrigation and Drainage, Tuaran). D. The 'Stair without pole' house on Oct 2000 showing the trace of water level (arrow). View to the east. E. Site of demolished 'stair without pole' house on 22 February 2001, views to the east. F. Demolished house in the swampy area and grass field in the new natural sediment trap originated from paddy field. G & H. Flash flood on 13 August 2005 at km 26.5 of Tuaran road.

This improper planning has led to the congestion of the drainage flow that cause runoff overflow or flash flood problem to submerge the settlement houses (Figure 7C), lower part of the road (Figure 7G & 7H) and paddy field area (Figure 7F).
