GEOHAZARDS IN SANDAKAN TOWN AREA, SABAH, MALAYSIA

Rodeano Roslee^{1,2}¹ Natural Disaster Research Centre (NDRC), Universiti Malaysia Sabah² Faculty of Science and Natural Resources, Universiti Malaysia Sabah

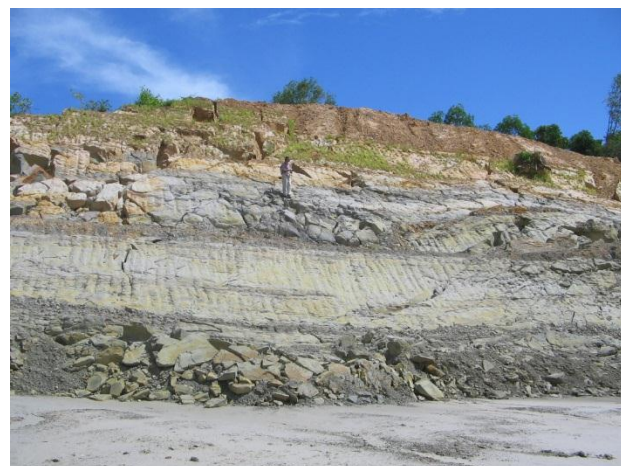
Figure 5: Outcrop generally consists of fine texture, cohesive materials, highly weathered to residual soil materials (Location: Sunny Estate)

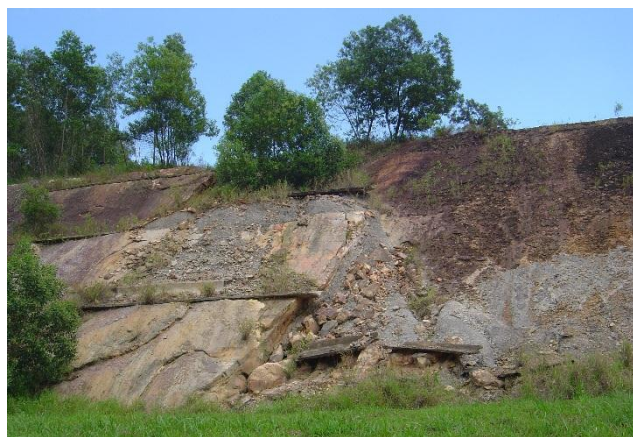
Figure 7: Dangerous slope failure near by the Indah Jaya

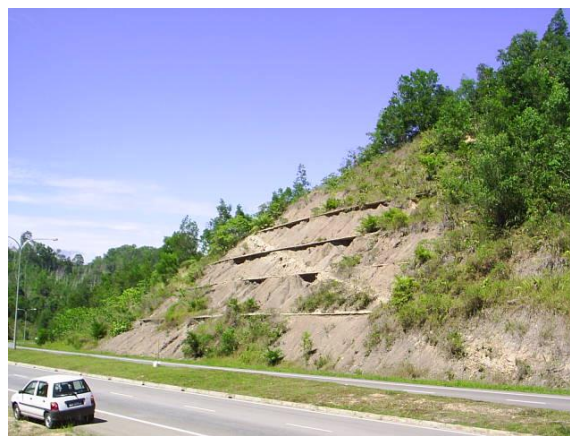
great destruction of life and property. Several factors contribute to occurrence of slope failure and these are categorized into geological, geomorphological, climatological, and anthropological. Included in the geological factors are: the dense occurrence of geological faults providing zones of weakness; the presence of clayey material within the sliding area. Geomorphological factors include steepness of slopes, relief, elevation, valley configuration and ridge form, deep tropical weathering, lack of tropical forest and high rainfall (Figure 7). The anthropological factors are those that result from man's activities such as steeping of natural slope due to road building, distability of slope toes due to road cutting and removal of vegetation protection (Figure 8). Consideration of these hazards must be put in development to counter their disruptive effects.

Figure 8: The cutting of hill slope, removing trees and vegetation from the hill slope reduces the stability of the slope (Location: Highway Batu Sapi - Sibuga)

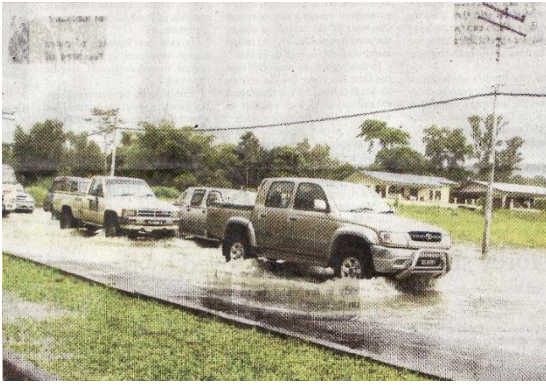
Artificial factor is man - made and attributed to the presence of the quarries. Quarry related activities create disequilibrium in the environment by contributing to the volume of materials brought into the drainage system. Subsequently, siltation rate is disproportionately increased, the river bed becomes shallow and water movement is restricted during rainy days (Figure 9).

Figure 9: Flash flood at Sibuga area [4].

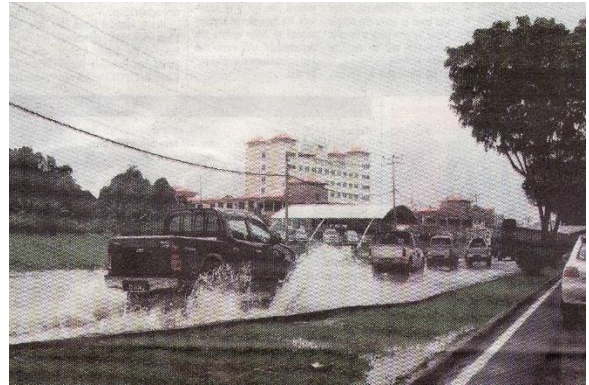
This factor pertains to infrastructure development in relation to drainage. Most of the road in Sandakan town area was designed lower than the surrounding area. In most of the areas, the drainages constructed a few centimeters below the roads are not will maintain in most of the drainage reached the road level due to dumping of various types of eroded materials. Runoff water, instead of flowing freely is restricted in the lower lands, which are located mainly along the main roads. Another factor, which contributes adversely to the above-mentioned situation the sub-stratum of the low land areas and the presence of tall grasses along the drainage lines, which further impede water movement. Most of the lowland flooding areas underlain by impermeable materials whose highly porous but low permeable characteristic will induce water absorption and retention and will eventually lead to flooding problem. On the other hand, the continuous growth of the drainage grasses may be attributed to the lack of regular drainage maintenance program (Figure 10).

Figure 10: Improper monitoring and maintenance of the drainage channel (Location: Mile 6) [5]

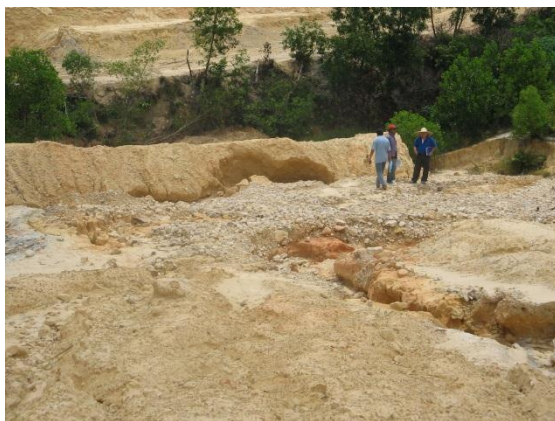
Figure 12: Intensively erosion processes (Location: a. Kim Fung and b. Sunny Estate)

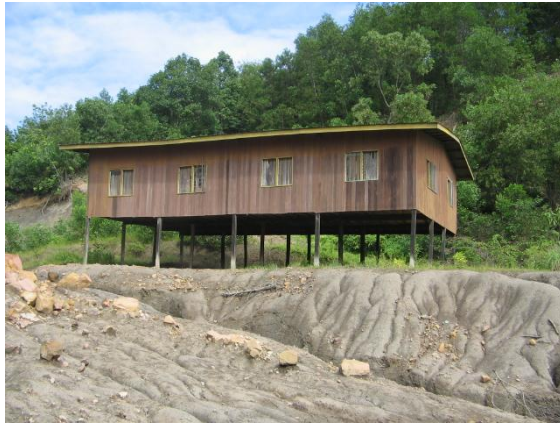
which experienced different consolidation and this situation always cause serious destruction to building structures (Figure 13a). In other cases, land subsidence is formed due to erosion of the land surface in round form and deep banks. This incident is linked with decreased in ground water table and caused destruction of properties and disturbance to traffic (Figure 13b).

Figure 13: Land subsidence occurrences (Location: a. Batu Sapi & b. Highway Batu Sapi – Sibuga)
