RESEARCH ARTICLE

ALKALI-SILICA REACTIVITY OF SOME GRANITIC ROCKS IN KUMASI, GHANA: IMPLICATIONS FOR USE OF ROCK AGGREGATES FOR CONSTRUCTION

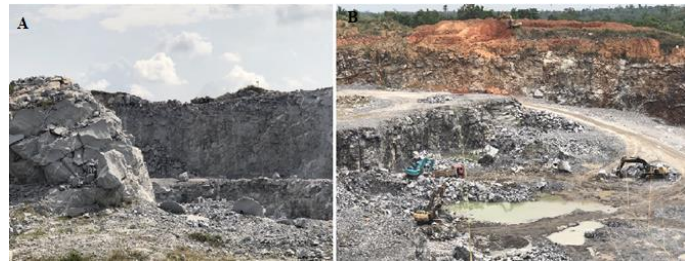
Figure 4: (A) Modern Granite Quarry at Buoho; (B) Nnagot Quarry at Kona

Rock samples and quarry dust were used in this project. These materials were sought from some of the most popular quarries in Kumasi, well-known for supplying granitic aggregates for construction works. The selected quarries are Modern Granite Quarry in Buoho (Figure 4A), Nnagot Quarry in Kona (Figure 4B) and Consar Stone Quarry Limited in Barekese. The samples were collected in sacks, well labelled and transported to the Geological Engineering laboratory and Geotechnical laboratory in K.N.U.S.T.

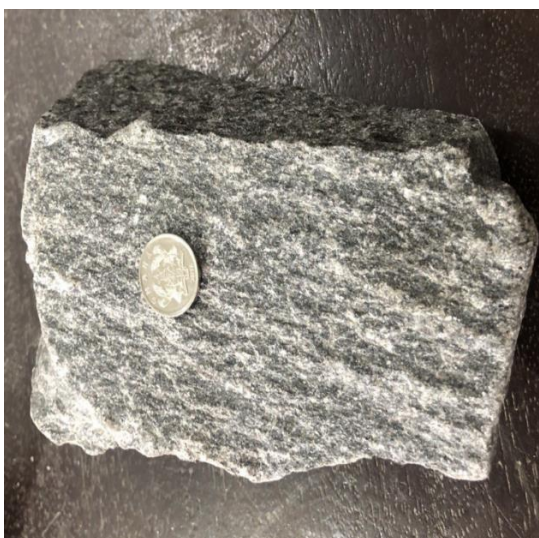
(A)

The rock sample (Figure 8A) is fine to medium grained and foliated subtly with bands of varying minerals. It is composed of quartz, biotite, and feldspar. The feldspar and quartz grains are in an interlocking texture.

Figure 8: Biotite Hornblende Gneiss (Kona) (A); Biotite Quartz Gneiss from Kona (B); Microcline Granite from Barekese (C); Microcline Quartz Granite from Buoho (D)

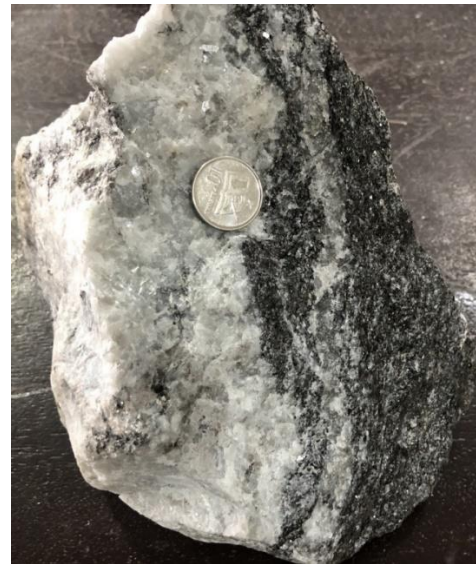
(B)

Rock (Figure 8B) is a combination of light and dark colored minerals. The light colored minerals are predominantly plagioclase with small amount of quartz and dark minerals are hornblende and Biotite. The rock is generally intruded by the feldspar and quartz veins which has formed bands on it. The dark minerals are medium grained and the light-colored minerals are porphyritic. The rock is foliated.

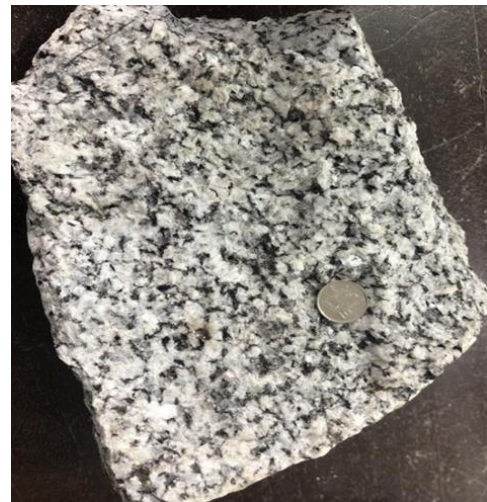
(C)

Rock (Figure 8C) is generally light colored with some dark minerals interspersed in it. It is composed of quartz, feldspar and biotite with the minerals interlocking each other. The rock is not weathered and the cock is coarse grained.

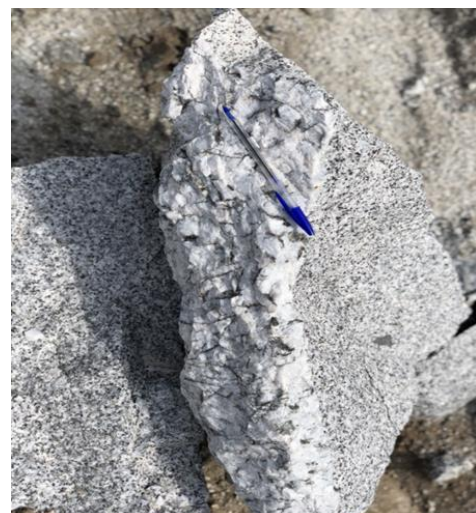
(D)

Rock (Figure 8D) has a porphyritic light-colored portion which is dominated by feldspar and quartz. The other portion is a combination of dark and light-colored minerals evenly distributed (which contains quartz, feldspar and biotite).

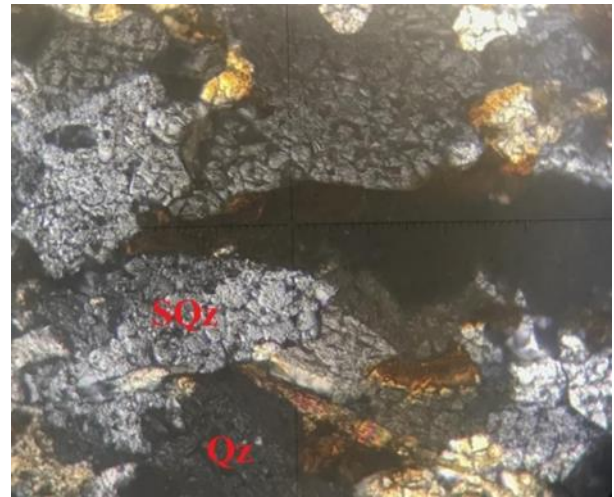
Figure 9: Photomicrograph of a biotite-hornblende gneiss under cross polarized light (4x magnification) sampled at Kona, showing: (A) minerals such as plagioclase (Pl), quartz (Qz), biotite (Bt), hornblende (Hlb); and (B) strained quartz in the gneiss rock

In thin section (Figure 9), the rock is medium grained and it is composed of biotite, quartz, plagioclase and hornblende which are mostly anhedral and interlocking. Biotite occurs in small sizes and has a tabular shape. Quartz grains are not distinct and are highly fractured. They exhibit undulose extinction at an angle of 24°. Plagioclase shows carlsbad (albite) twinning and they are surrounded by quartz and biotite grains. Hornblende grains are widely distributed in the rock and they turn greenish in color when rotated on the stage.

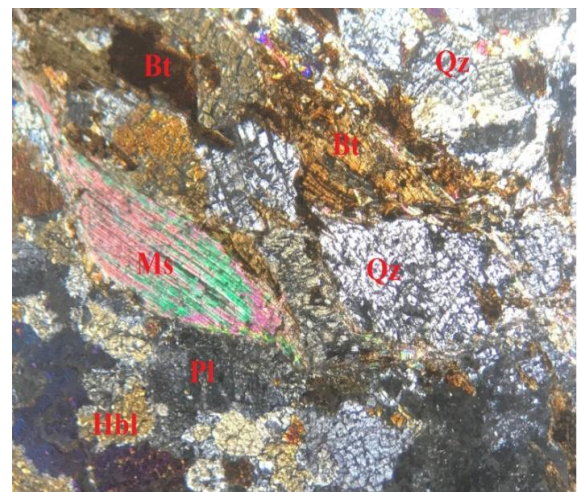
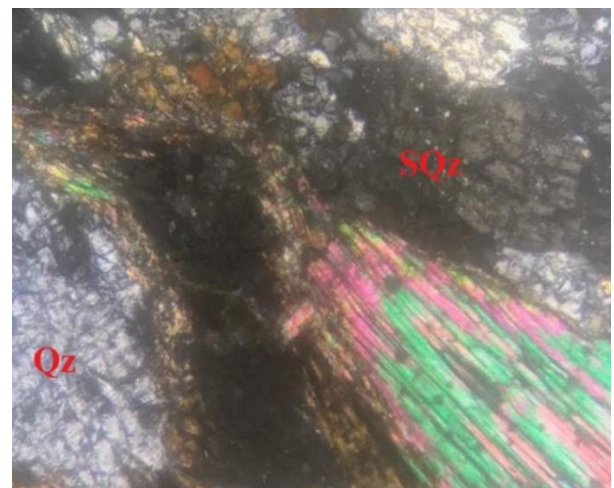
Figure 10: Photomicrograph of a biotite-quartz gneiss under cross polarized light (4x magnification) sampled at Kona, showing: (A) minerals such as plagioclase (Pl), quartz (Qz), muscovite (Ms), biotite (Bt), hornblende (Hbl); and (B) strained quartz (SQz) in the gneiss rock (Quartz grains are deformed and show slight undulose extinction)

In thin section, the rock sample (Figure 10A) is seen to contain biotite, quartz, hornblende, muscovite and some other minerals. The minerals are elongated and trending in the NW-SE direction. Biotite has a wood-like acicular habit with anhedral grains. Muscovite grains are bounded together and they have well-formed crystals which are elongated. Extinction angles are parallel to cleavage in all directions. Quartz grains are widely spread in the rock with fractures. The grains exhibit undulose extinction (Figure 10B). The measured extinction angle is 26° (Figure 10B) which gives an indication of some deformation in the quartz grains. Extinction angle of about 25° and thus indicates that the rock is potentially reactive.

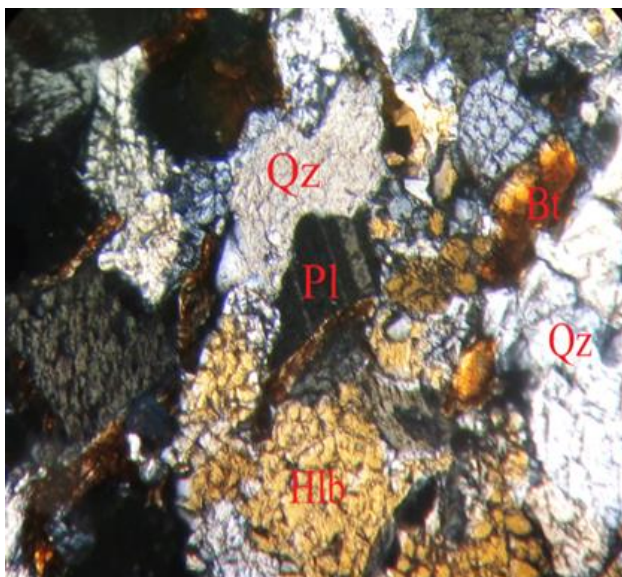
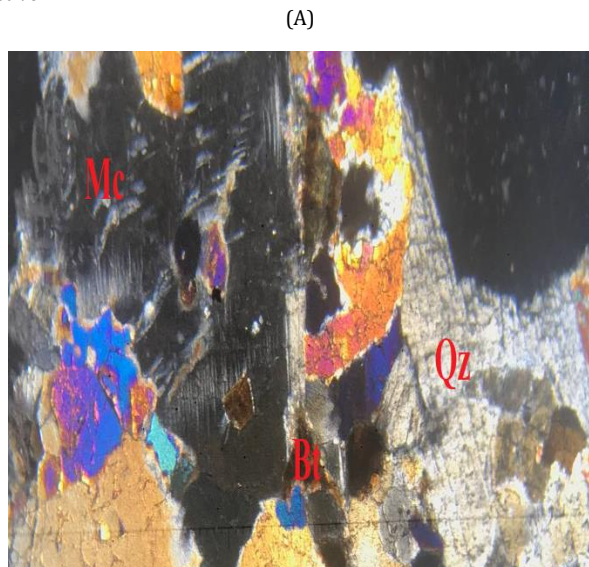
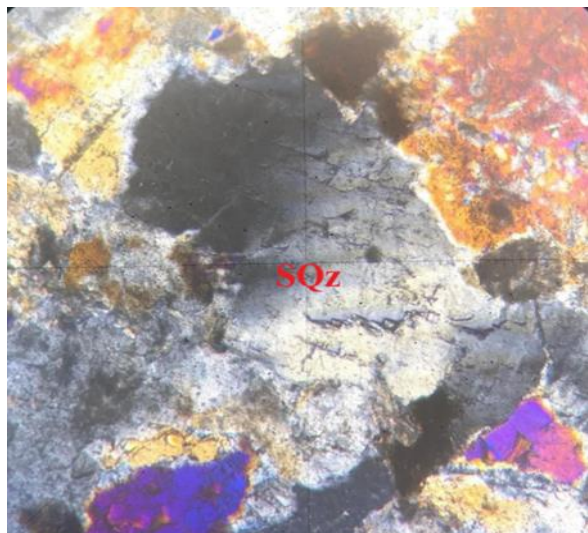
Figure 11: Photomicrograph of a microcline granite under cross polarized light (4x magnification) sampled at Barekese (mineral grains are poikilitic), showing: (A) minerals such as microcline (Mc), quartz (Qz), muscovite (Ms), biotite (Bt); and (B) strained quartz (SQz) in the granite rock (Quartz grains are deformed and show slight undulose extinction)

The thin section of the granite sample (Figure 11) contains biotite, microcline, quartz and some other minerals. The grain sizes are medium to coarse grains. Biotite grains are dispersed in the rock and are surrounded by microcline grains and quartz grains. Microcline grains are widely spread in the rock and the grain sizes are massive and has a poikilitic texture. They have perfect cleavage and show distorted cross-hatch twinning. Quartz grains in the rock are highly fractured and exhibit undulose extinction which are wavy in nature (Figure 11B). They extinct at an angle of about 19° hence they are innocuous.

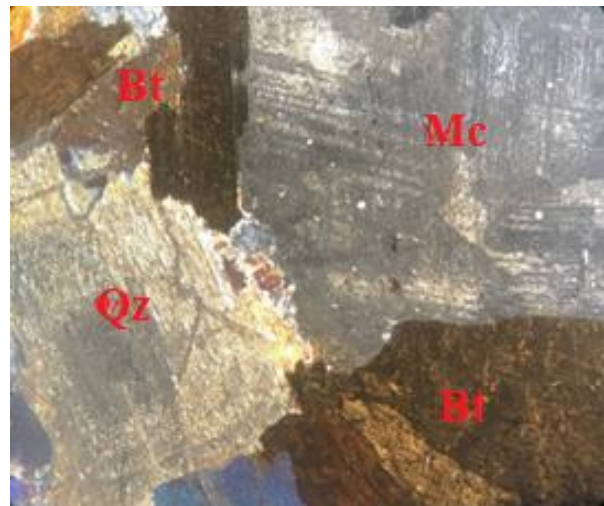
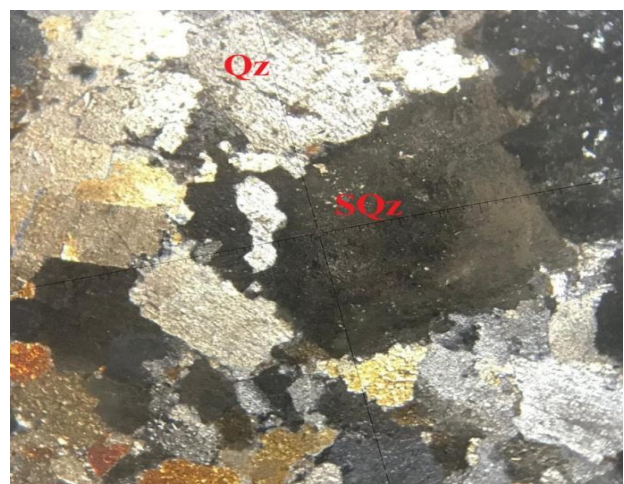
Figure 12: Photomicrograph of a microcline granite under cross polarized light (4x magnification) sampled at Buoho, showing: (A) phenocrysts such as microcline (Mc), quartz (Qz), muscovite (Ms), biotite (Bt); and (B) strained quartz (SQz) in the granite rock

The thin section of the microcline-quartz granite sample contains phenocrysts of microcline, biotite and quartz. Mineral boundaries are distinct. Microcline grains are subhedral and shows distorted cross-hatched twinning. Biotite exhibits a woody habit and shows parallel extinction. Quartz grains are anhedral and has some cracks in them. Quartz has an extinction angle of about 15° (Figure 12B).
