GEOHAZARDS IN SANDAKAN TOWN AREA, SABAH, MALAYSIA

Rodeano Roslee^{1,2}¹ Natural Disaster Research Centre (NDRC), Universiti Malaysia Sabah² Faculty of Science and Natural Resources, Universiti Malaysia Sabah

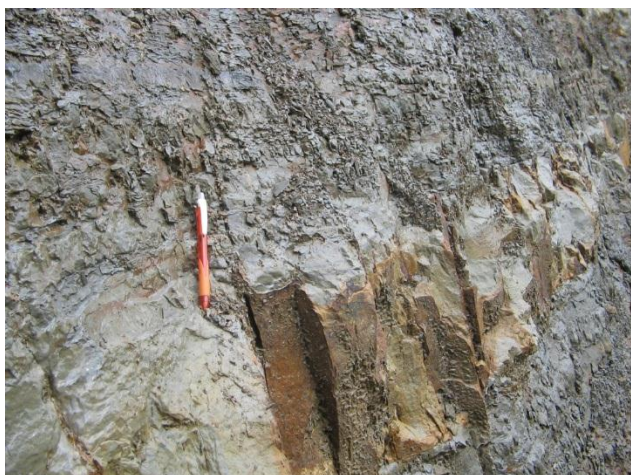
Figure 4: A block of sub greywacke in clay matrix, slump breccia (Location: Indah Jaya)

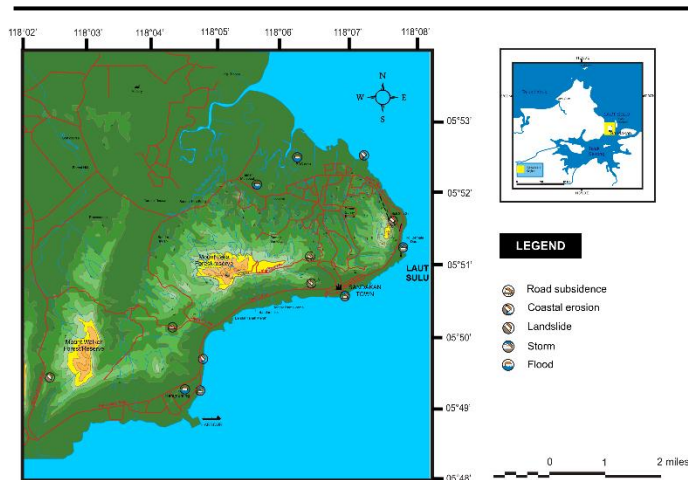
without any early indication or insufficient information concerning the hazards. In the Sandakan town area events such as slope failure, flash flood, erosion and land subsidence form as the main geomorphological

hazards, which had caused much destruction of properties, increased the controlling cost, disturbance to public convenient and caused death (Figure 6).

Figure 6: Geohazards map

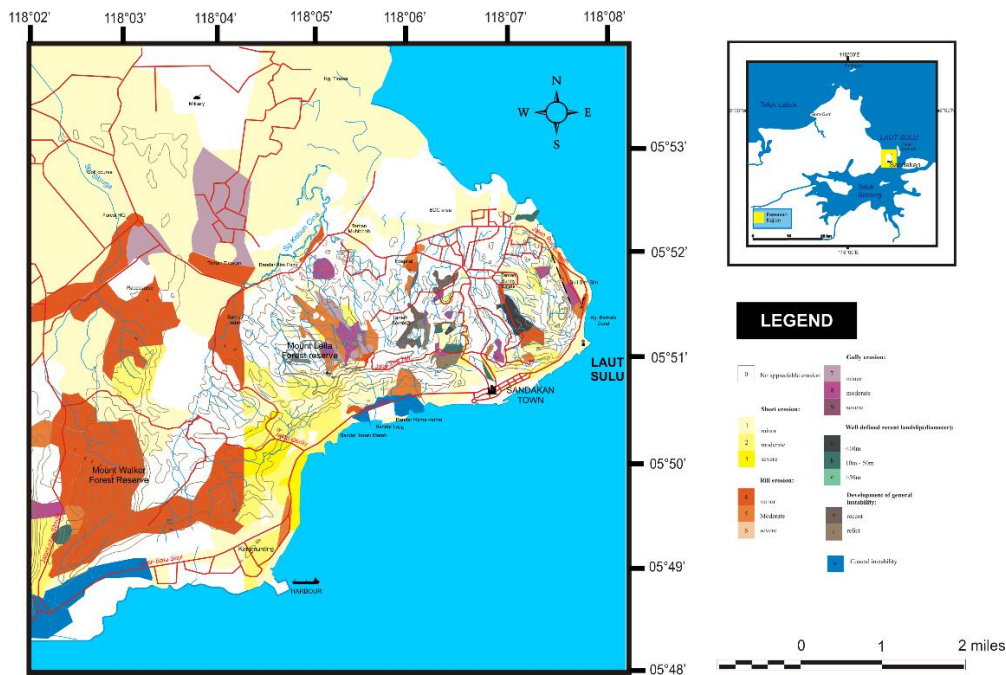
Erosion is a process involving the removal of solid particles by action of water and wind, generally resulting in denudation or height reduction. Erosion was geomorphological hazards phenomenon which often threatened settlement (Figure 11). Incident become more critical because there was squatter's settlement along the river bank or near by the river areas. Erosion involves the reduction of mass and is commonly observed in the study area at beaches and coastal areas (Figure 12a), extending from Sandakan town towards the northern and eastern part of the study area (Figure 12b). Dominant force in this erosion is periodic motion of the waves, aided by low and high tides. Prominent signs erosion can also be found at exposed hill tops and slope cuttings, where rain and other natural

Figure 11: Erosion map of Sandakan town area
