GEOTECHNICAL INVESTIGATION OF THE PROPOSED IFE DAM SITE AT KAJOLA VILLAGE, ILE-IFE, SOUTHWESTERN NIGERIA

Geological and geophysical investigations were conducted to assess the competence and structural integrity of the foundation site of the proposed Ife-dam at Kajola Village, Ile-Ife, Southwestern Nigeria. Geological investigation along the two (2) proposed dam axes revealed that the overburden material is loose to dense with angular shearing resistance (ϕ) of 27° to 41°. The soils are predominantly elastic silts; cohesive with considerable strength and stability. Geophysical investigation involving the Schlumberger Vertical Electrical Sounding delineated four (4) lithologies namely: topsoil with resistivity of 69 – 558 Ω m and thickness between 1.5 and 4.0 m; weathered sandy layer with resistivity from 123 – 586 Ω m and thickness between 6.5 and 20.4 m; partially weathered/ fractured basement with resistivity from 60 – 220 Ω m and thickness between 6.5 and 14.0 m; and the fresh basement rock with resistivity from 1337 – 10683 Ω m. There are indications of fractures at a depth of 32 m beneath Axis B extending to Axis A at a depth of 35 m. The subsurface materials are suitable to

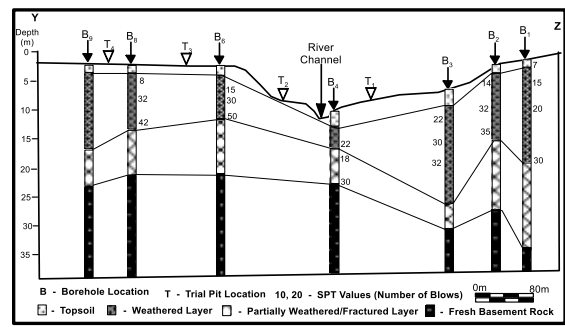
Figure 4: Lithological Section along Dam Axis B

Based on physical observation of the ditch cuttings from the boreholes and trial pits, the subsurface lithologies underlying the dam axis were reconstructed. Correlation of the subsurface lithologies across the boreholes showed four subsurface layers (Figs. 3 and 4). These include the topsoil with thickness ranging from 0.8 m beneath Borehole 10 to 3.5 m beneath Borehole 3; clayey weathered layer with thickness ranging from 4.0 m beneath Borehole 4 to 19.5 m beneath Borehole 16; partially weathered layer with thickness ranging from 3.5 m beneath Boreholes 13 and 16 to 15.0 m beneath Borehole 1; and the fresh basement rock. The soil permeability ranged from $0.07 \times 10^{-6} \text{ cm. s}^{-1}$ to $13.09 \times 10^{-6} \text{ cm. s}^{-1}$ (Figs. 5 and 6). The permeability of the topsoil was not estimated. The permeability of the clayey weathered layer was $2.45 \times 10^{-6} \text{ cm. s}^{-1}$, while that of the partially weathered layer was between $0.07 \times 10^{-6} \text{ cm. s}^{-1}$ and $13.09 \times 10^{-6} \text{ cm. s}^{-1}$. There is a general decrease in soil permeability from the second to the third layer. This decrease in soil permeability could be attributed to the increase in soil compaction with depth, resulting in reduced porosity and interconnectivity of pore spaces. The exceptionally high permeability of the partially weathered layer at a depth of 32 m beneath Borehole 1 is attributed to the occurrence of fractures, which could serve as flow paths for groundwater. The occurrence of the fractures is responsible for the high degree of weathering observed in Borehole 1 (Fig. 5).

SPT carried out in the boreholes revealed increasing numbers of blows with depth (Figs. 3 and 4). The increase in numbers of blows with depth indicates an increasing soil density arising from increased soil compaction with depth. Based on the SPT the soils underlying the dam axes are classified as loose to dense soils, with angular shearing resistance (ϕ) between 27° and 41° (Fig. 7). The moisture content obtained for the soil samples ranged between 11.79 % and 42.00 % (Table 1). The moderate values of moisture content indicate that the soil samples are slightly moist to moist. Six (6) out of the ten (10) soil samples had moisture content between 11.79 % and 29.90 %, while the remaining four (4) soil samples had moisture content between 39.99 % and 42.00 %. The large number of soil samples that are slightly moist is an indication of the clayey nature of the soils and the presence of relatively moderate levels of groundwater in the study area. The water table obtained from trial drill pits and boreholes range between 7 m and 15 m (Das, 2010).

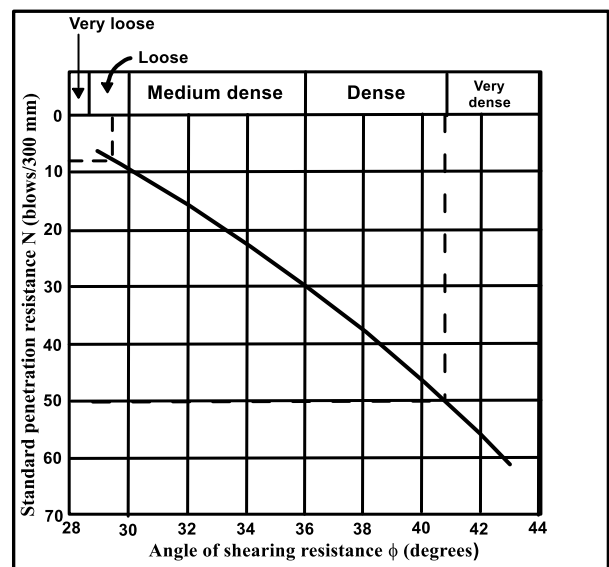
Figure 7: Relationship between SPT Values and Angle of Shearing Resistance (Peck et al., 1967)
